Background

The home at 11236 Race Street in the College Meadows subdivision (Lot 52, Third Plat) was completed in December 2016. Following construction, the home flooded in 2017, 2021, and 2024 and the homeowners have incurred significant costs for cleanup and repair of damages. The following is the timeline of the flooding and the actions taken:

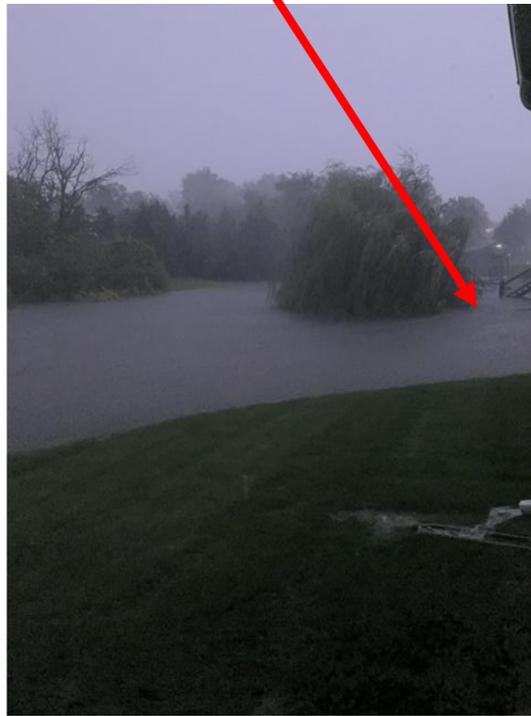
2017 Flooding

- Johnson County's Stormwatch Gauge ML02 - Mill Creek @ College Blvd., located ½ mile east of the home, recorded 5.12" of rainfall in approx. 13 hours with a peak 1-hour intensity of 2.25" in/hr. and a peak 15-minute intensity of 3.2 in/hr.
- Stormwater runoff swamped the subdivision's storm drain system and flooded the rear and side yards around the home 4 to 5 feet deep. The water filled the window well, intruded into the basement to a depth of 3"-4". The drywall was damaged from the floor up to approximately 24". It was cut away and replaced during flood mitigation repairs. Out of pocket - \$2,000.
- C.W. Concrete was contacted by the homebuilder, and they re-poured the window well with an extra 3' as the owners were told that was the point of entry into the house for the water.
- The City of Olathe deemed that the flood was because of the foundation issue.

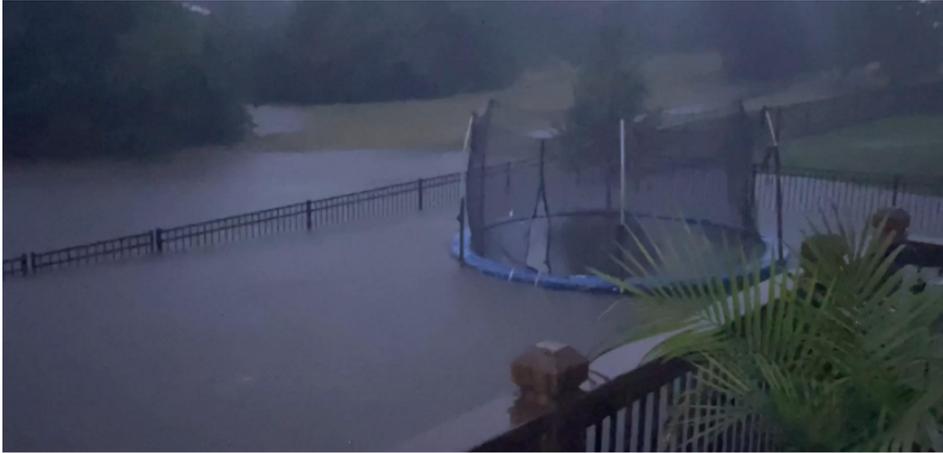
Image 5 - Water level seen in lightning strike of the “shallow” end of the created pond.

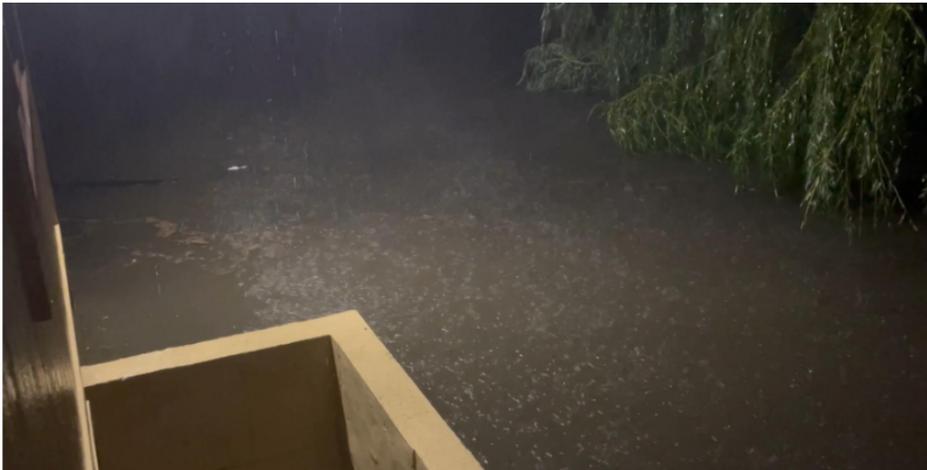
Image 6 - Fence line barely visible on the SE side of the house and this was not the max level. The new higher window well was not breached.

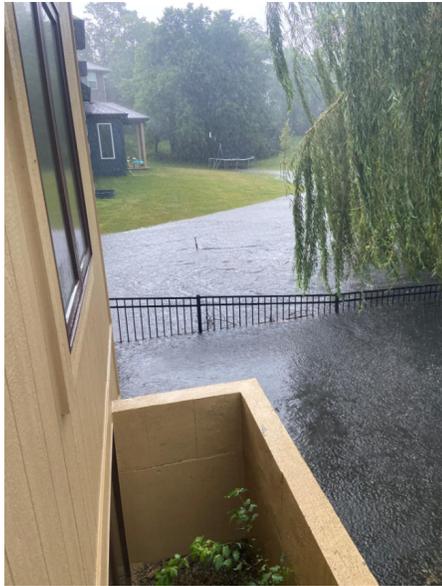
Image 10 - Water level not yet at peak while raining.

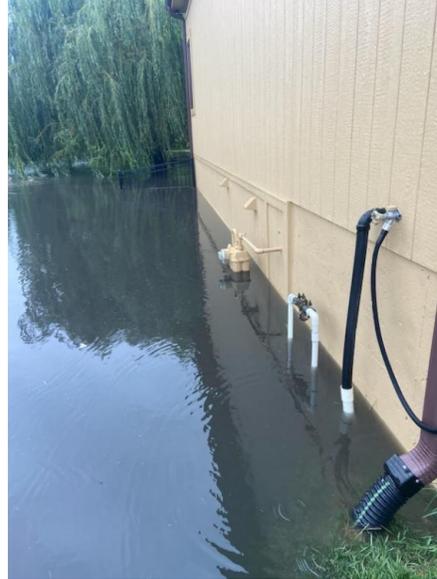
Image 12 - Side of house with standing water at 4'+.

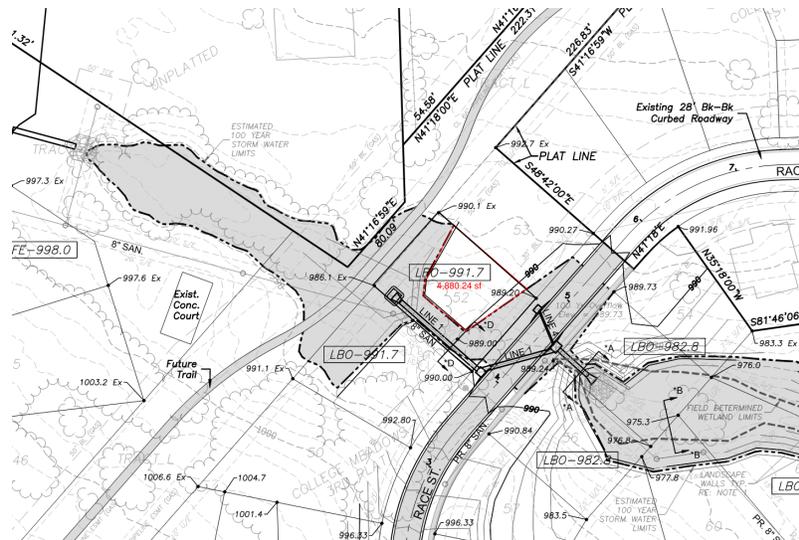
The grading plan shown below was prepared by the engineer and it shows the extent of potential flooding during the large storm events. It indicates that nearly 55% lot 52

was predicted to be flooded with only the footprint of the future home above the flood level. Lot 51 shows similar flooding, though not to the same extent.

The grading plans also show that the future home should have a low building opening (LBO) of 991.7' to avoid direct entry of flood waters into the home. This LBO would have required the first-floor elevation of the home to be approximately 995' or six feet higher than the street grade in front of lot 52. Grading the lot to achieve this would have been very difficult and undesirable for a future homeowner.

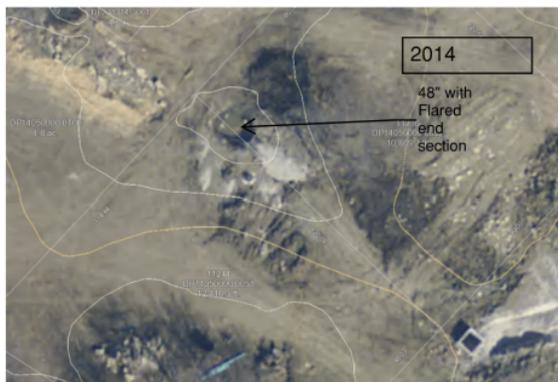
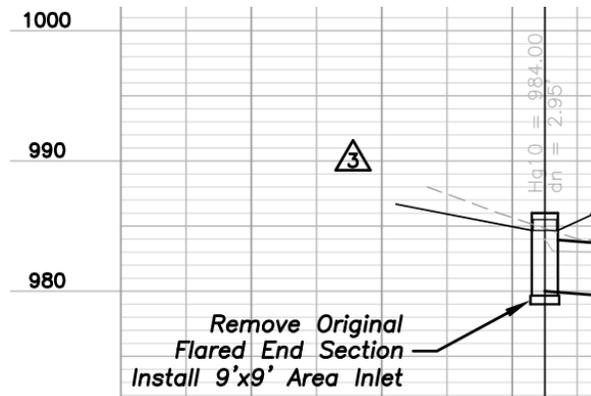
Construction of the 3rd Plat took place in 2014 and 2015, and the pipe and end section were installed as permitted. However, the developer replaced the flared end section with a 9' x 9' field inlet during construction and recorded this on "As-Constructed" drawings submitted in August 2015. No reason was given for the change, but it was likely due to issues with grading lots 51 and 52.

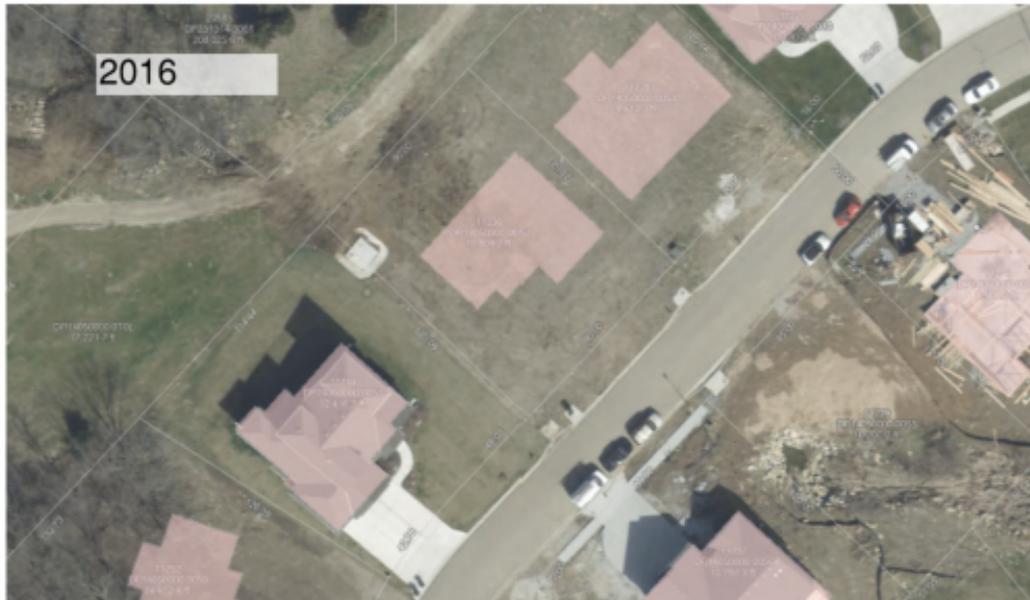
The photo below from 2016 shows the field inlet that replaced the flared end section.

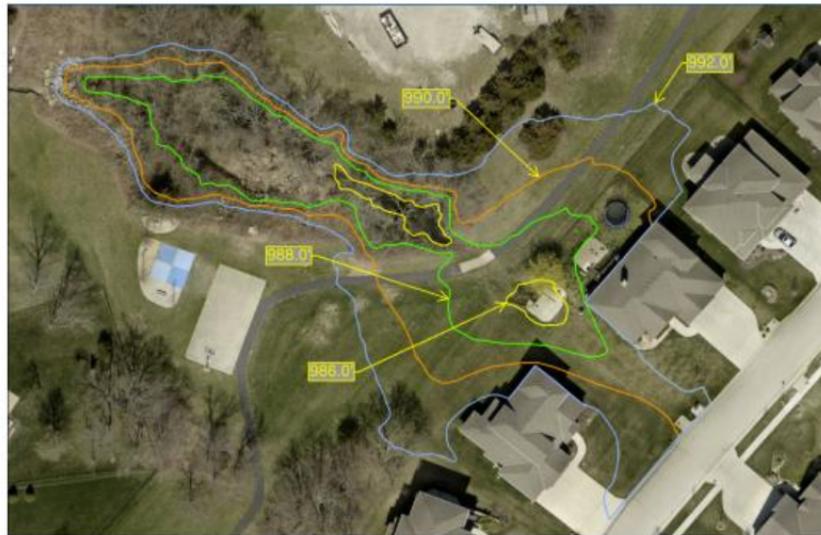
Figure 5: Pond Elevations

The analysis concluded that the backyards of lots 51 and 52, in combination with the field inlet and the low area to the west, were acting as a detention pond for stormwater flows up to 992' as shown in the screen capture from the report shown on the following page. It also concluded that the home flooded because it was built 2.46' lower than the proposed elevation shown in the development plan and water could enter through the LBO prior to construction of the window well extension. The analysis also identified several discrepancies associated with the design of the stormwater system including:

The backyard was modeled in civil storm as a detention pond. The pond was depicted using an elevation-area table, which is listed in Table 3.

HNTB's analysis showed that flooding could be relieved by replacing the 48" pipe and inlet with an 8' x 4' concrete box culvert and new field inlet with open cell grating on the top. The box culvert has nearly 3 times the cross-sectional area of the 48" pipe. The cost of the improvements was estimated to be \$466,000.

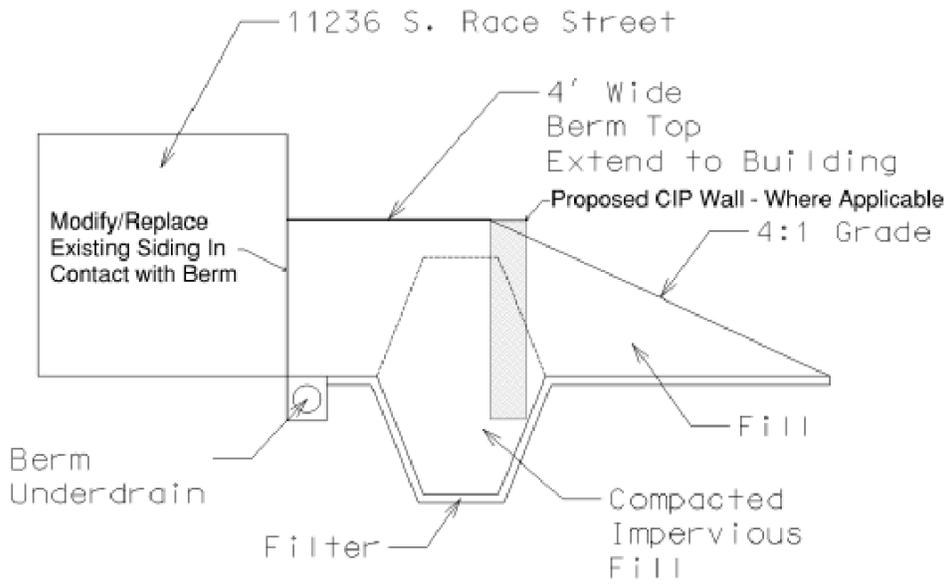
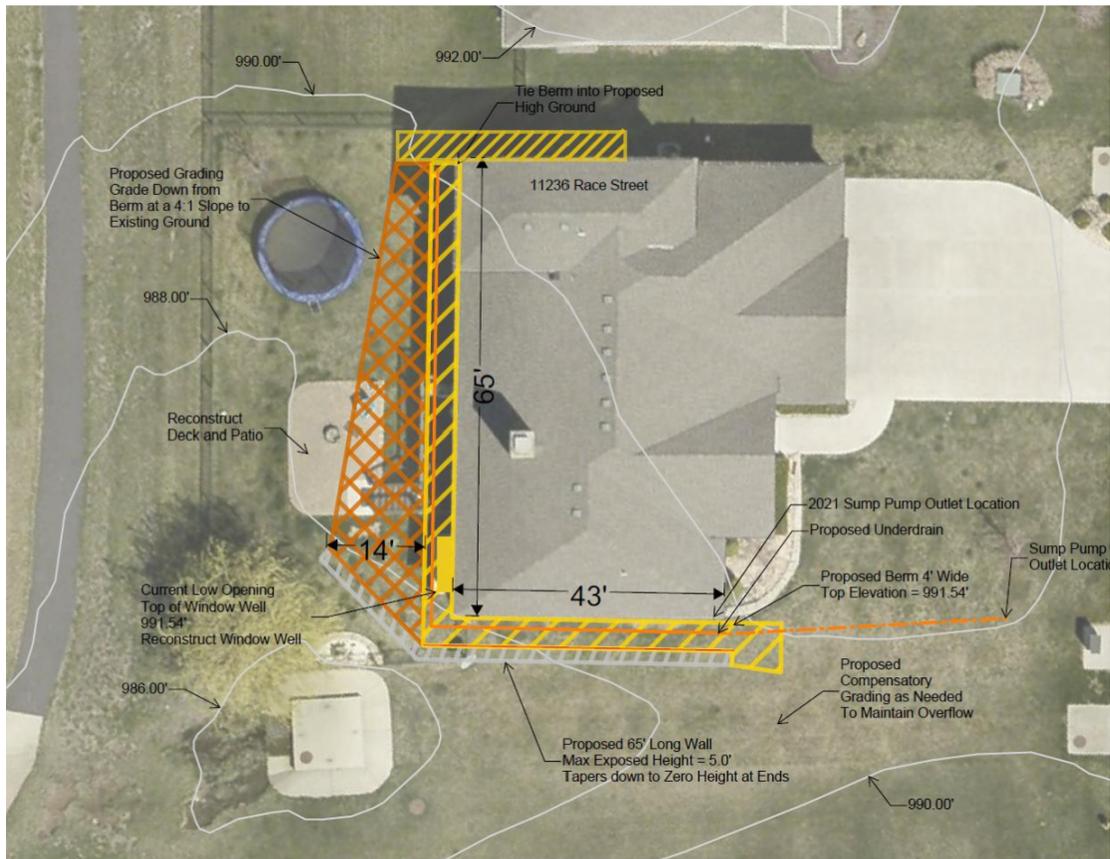
Figure 1: Proposed Berm

The estimated cost of the improvements is \$140,000 and the city proposed spitting the costs with the owners. Although the improvements are potentially feasible, they are undesirable for the following reasons:

- The root causes of the flooding are not being addressed. The owner's yard will continue to flood during large storm events.
- The berm and wall will make a large portion of the back and side yards unusable.
- The existing deck and patio will have to be torn out and the patio will have to be located near the rear fence.
- The proposed improvements will not guarantee that water will not intrude into the home.

- Construction of a 4' tall, 4' wide berm with an impervious core against the entire side and back of the home.
- The berm has a 4:1 grade from the top to the current backyard. This 25% slope is considered a moderate to steep grade for walking.
- A 65' long, 5' tall, concrete wall that runs the length of the side of the home and then cuts across the current fence line at a 45-degree angle, intruding into the yard approximately 22'.
- Improvements to the foundation drain and sump pump system
