Background

The home at 11236 Race Street in the College Meadows subdivision (Lot 52, Third Plat) was completed in December 2016. Following construction, the home flooded in 2017, 2021, and 2024 and the homeowners have incurred significant costs for cleanup and repair of damages. The following is the timeline of the flooding and the actions taken:

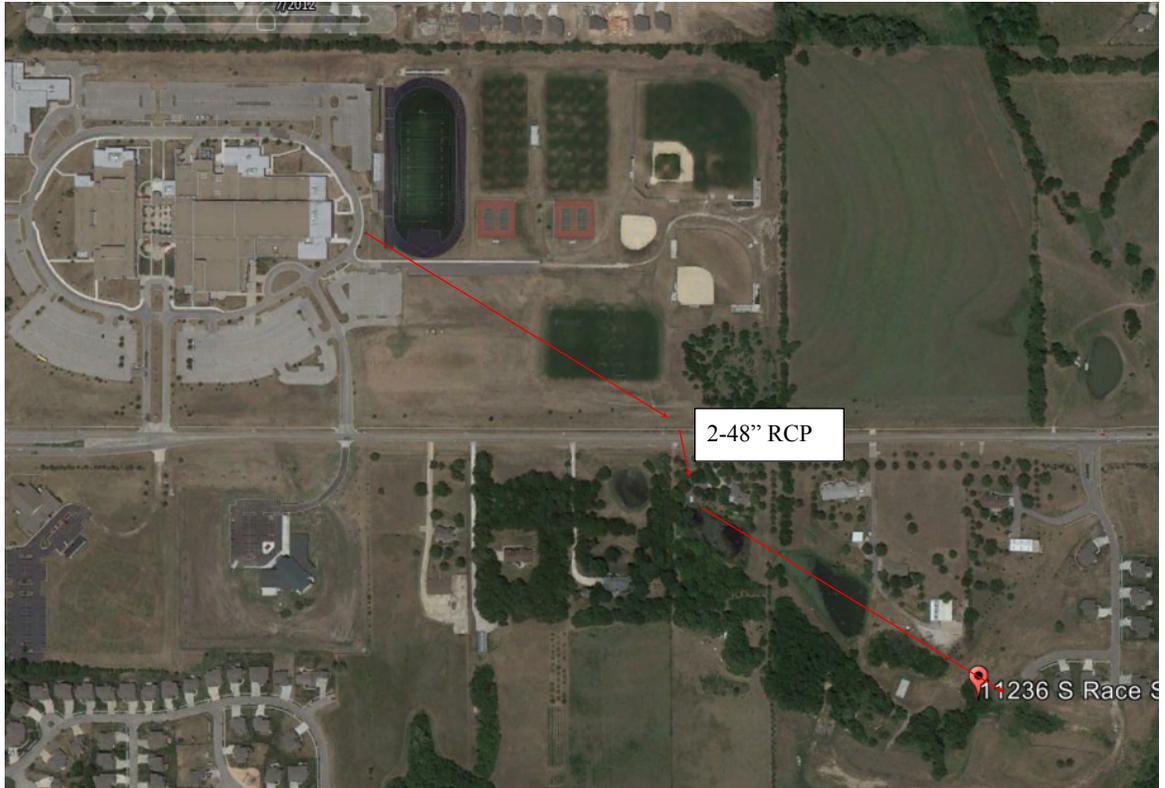
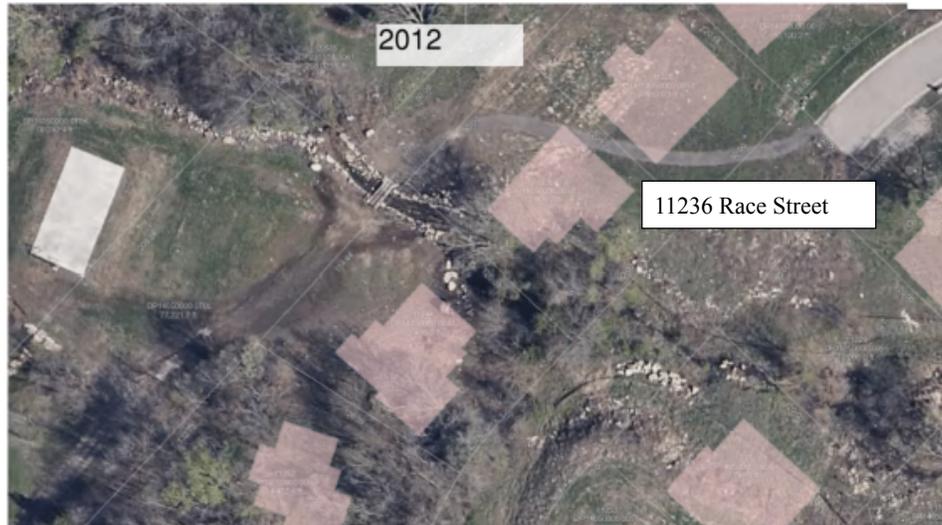
2012 Aerial Photography from Google Earth

Images from 2012 were obtained from Google Earth and Johnson County AIMS to demonstrate conditions prior to development of the 3rd Plat of the College Meadows subdivision (see next page). Development within the watershed upstream of future 11236 S Race Street was limited to Olathe Northeast High School and homes on large lots south of College Blvd. College Blvd. was a two lane road in 2012 and most stormwater runoff from the road and high school was collected by an enclosed storm drain system and conveyed to the south via 2-48" RCP culverts under College Blvd. Stormwater then flowed in a southeastern direction through a series of ponds and a low area and into a channel that ran through the future phase of the College Meadows subdivision to a tributary of Mill Creek. The historic channel ran through Lot 52 of the subdivision and would have been located along the south side of the future home.

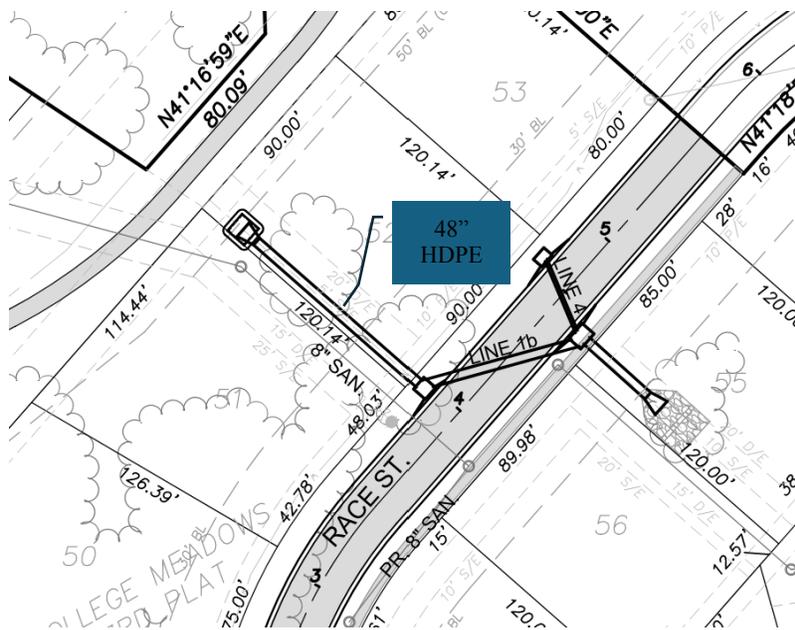
Street and storm sewer plans for the 3rd Plat were developed in 2014 by Gary T Spehar Engineering and Planning, and the storm sewer plans called for replacement of the channel through Lot 52 and under Race Street with a 48" diameter HDPE pipe as shown below. The pipe was to have a flared end section at the upstream end, and it was

designed to convey runoff flows from the 10-year storm and a portion of the flow from the 100-year storm. The remainder of the flows from the 100-year storm were to be conveyed over land and across Race Street with a depth of less than 6".

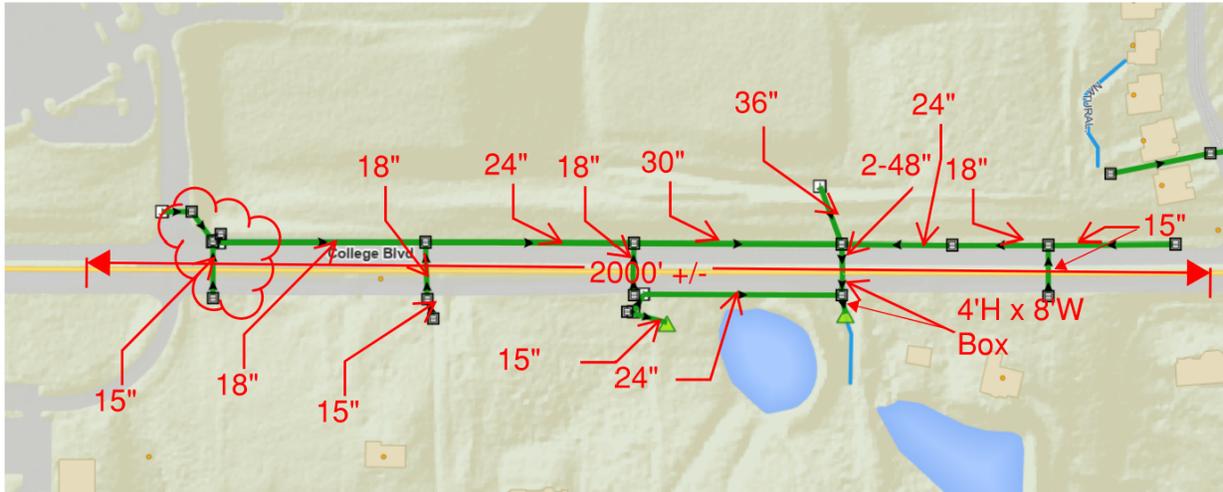
College Blvd Storm Drain System Within Watershed

Hydrologic and hydraulic modeling would be required to determine the effect of road expansion on peak runoff rates. However, it is logical to conclude that the increase in the impervious surface area and the construction of an expanded enclosed storm drain system would result in increased flows seen in the downstream system at Race Street. The design engineer would not have taken this into account when preparing the plans for the subdivision because the road was not designed until after the subdivision was permitted.

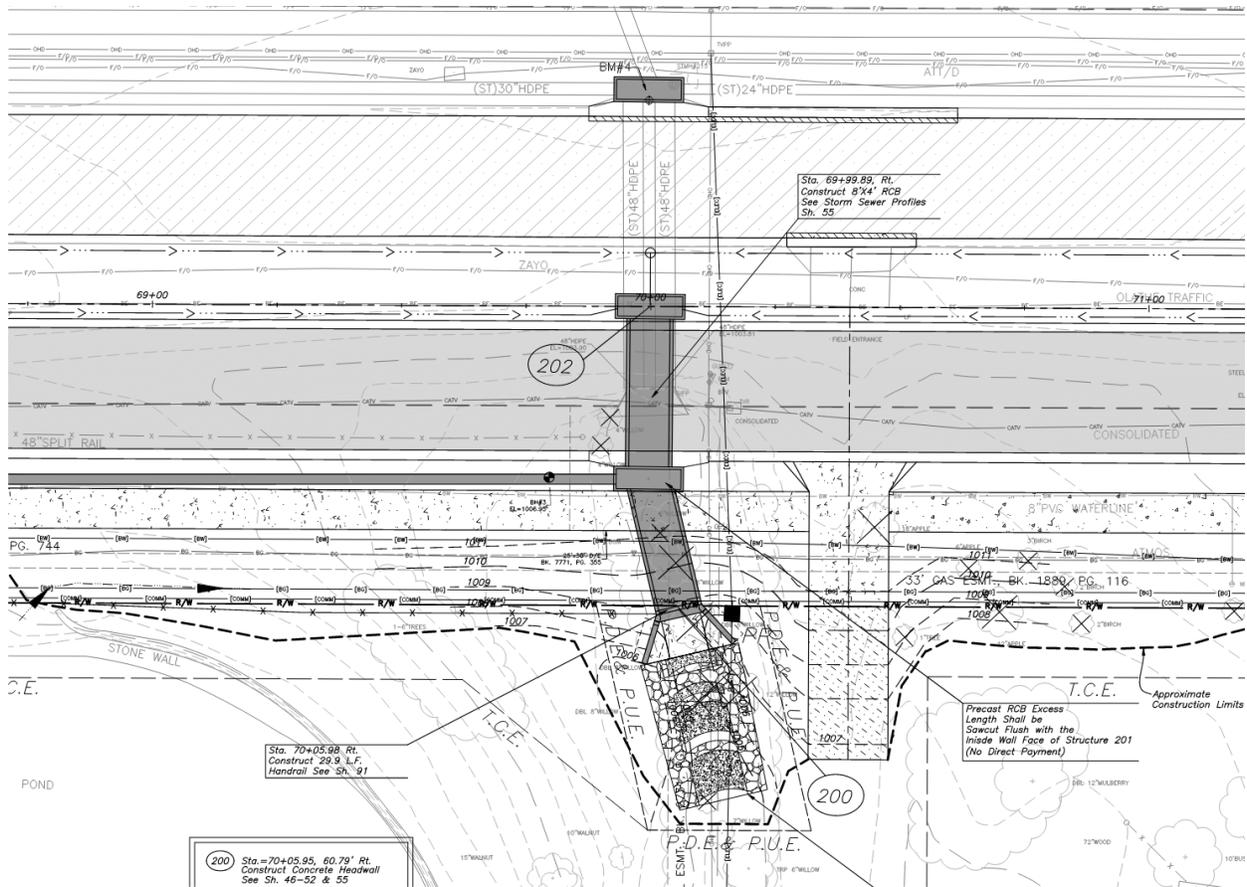
Historic and Expanded Storm Drain System Under College Blvd.

- The design engineer should have reviewed the extent of the upstream storm drain system and if this had been done, he would have noted that 2-48" RCP's conveyed flow under College Blvd. Justification would have been needed to reduce conveyance capacity downstream to a single 48" under Race Street.
